# EVALUATION OF PERIODIC CONTROL RESULTS OF ELEVATORS, CASE OF ÇORUM PROVINCE

In this study, the annual periodic control results of the elevators in Çorum in 2017, 2018 and 2019 are evaluated. The sources of the deficiencies encountered in the operation of the elevators and the relevant regulations are explained.

# Periodic Control Results of Elevators in Çorum

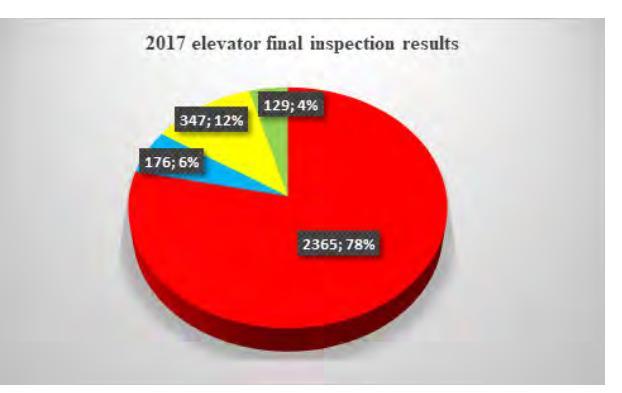
Figure 1. 2017 elevator periodic control results

In 2017, a total of 3017 elevators were periodically checked, including periodic checks before registration. As a result of the controls, red labels were attached to 2365 elevators, yellow labels to 347 elevators, blue labels to 176 elevators and green labels to 129 elevators. According to these results, only 10% of the elevators inspected could pass the inspection as slightly defective or flawless.

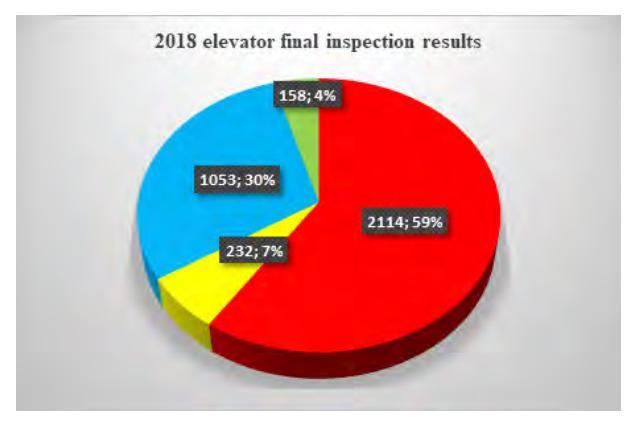
Figure 2. 2018 elevator periodic control results

In 2018, a total of 3557 elevators were periodically checked, including periodic checks before registration. The reason for the increase in the number of elevators inspected compared to the previous year is the addition of the periodical checks of the newly built elevators to the number of pre-registration checks and the existing elevators that have been newly detected. As a result of the controls, red labels were attached to 2114 elevators, yellow labels to 232 elevators, blue labels to 1053 elevators, and green labels to 158 elevators. According to these results, 34% of the elevators were directly inspected as slightly defective or flawless.

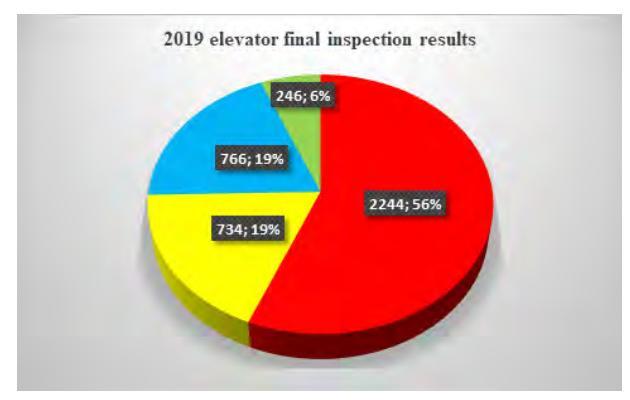
Figure 3. 2019 elevator periodic control results

In 2019, a total of 3990 elevators were periodically checked, including periodic checks before registration. As a result of the controls, red labels were attached to 2244 lifts, yellow labels to 734 lifts, blue labels to 766 lifts, and green labels to 246 lifts. The rate of elevators that passed the inspection as slightly defective or faultless was 25%. Compared to the previous year, it is noteworthy that the rate of elevators that were directly examined as slightly defective has decreased and the rate of defective elevators has increased. It can be said that the color changes made in the elevator control list by the Ministry of Industry in 2018 caused this result, albeit partially.

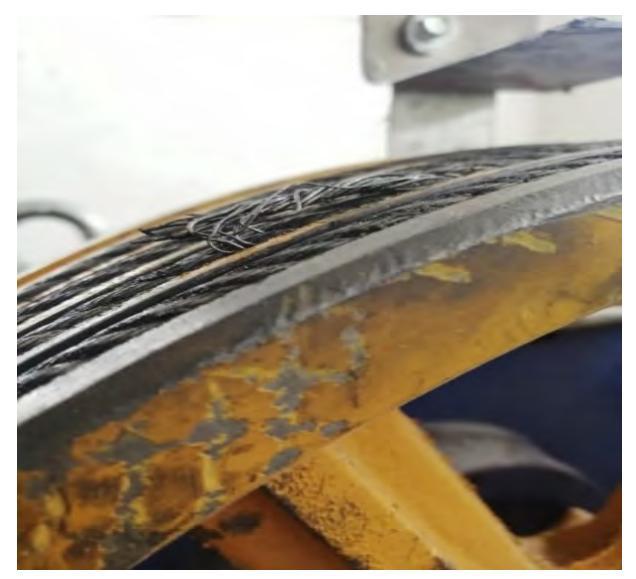
Picture 1. Deformed rope and worn pulley

There are cases where the suspension ropes are deformed, there is excessive lubrication, and there are missing nuts, gupilya, and terminal blocks in the cabinet and counterweight connections. There have been cases where the on-board maintenance control did not work, there were no direction signs, the stop and revision buttons were not protected against accidental operation, and the revision limit breakers did not work. The most common deficiency in 2017 is the unsuitability of the cabin skirt sheets. Even if there is no skirt sheet, it is considered as a serious defect if it does not comply with the standards.

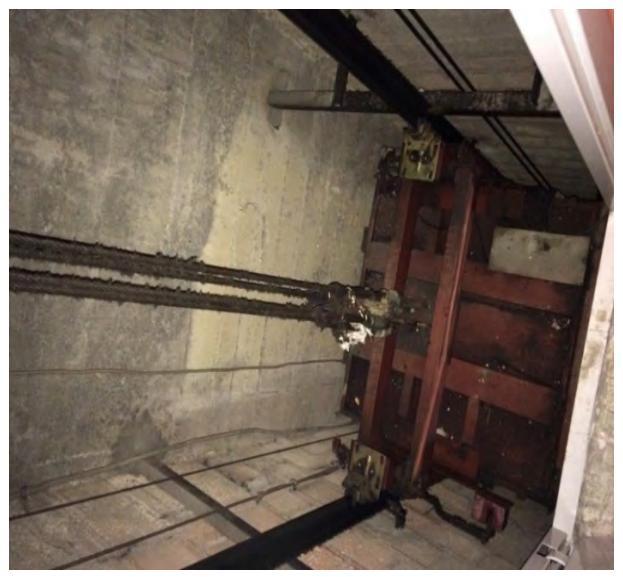
In cases where the cabin load exceeds 10%, the door must be opened by giving an audible and visual warning and an overload warning in the cabin and the elevator must not move. During the inspections, elevators that did not meet this requirement were observed. It has been determined that some elevators do not have the necessary guardrail for the personnel on the car to work safely.

Picture 2. Absence of guardrail on the cabin and maintenance control

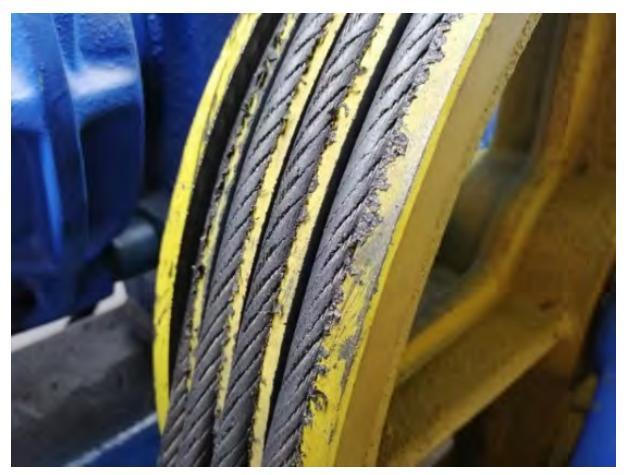
There have been cases where the mounting bolts of the drive machine's machine stand are mounted in reverse, the brake lever does not or does not work, and the brake adjustment is not appropriate.

Picture 3. Worn pulley and lack of rope tension adjustment
